Independent Engineering Report

Aguirre Power Plant Complex

Report SL-015976.AG

September 24, 2021

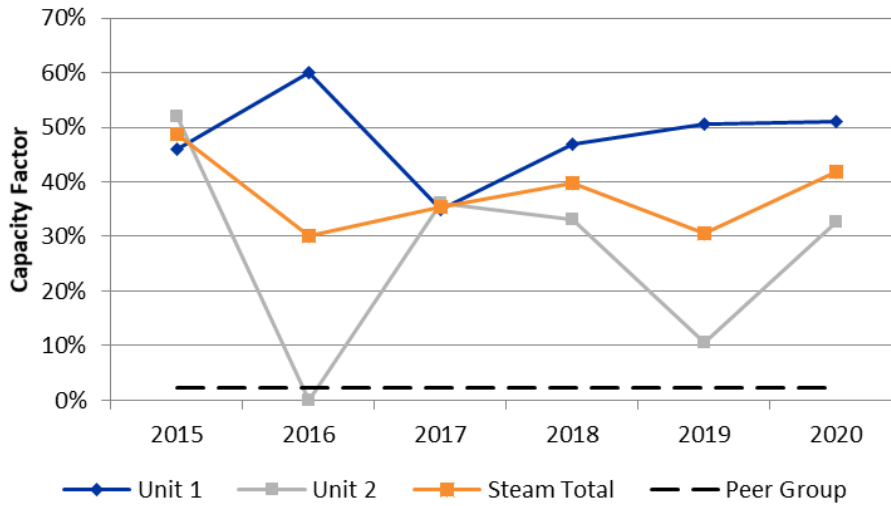
Figure 6-15 — Aguirre Thermal Plant Capacity Factor

The NCF plots for Aguirre thermal Units 1 and 2 are provided in Figure 6-15. The NCF for Units 1 and 2 follows the same trend seen in the generation information above. The NCF is high in the same year that the unit has high generation, and it is low when the generation is low. In 2016, Unit 2 has 0% NCF because it was out of service with extended STG issues. With Unit 2 out of service in 2016, Unit 1 had its highest NCF over the past five years at 60%. Unit 1's lowest capacity factor in the past five years was 35% in 2017 (likely due to the hurricanes of that year). Unit 2 was at its high in 2015 at 52%. These capacity factors are significantly higher than its peer group and shows the Aguirre thermal units are used generally for base load while the peer group is used for peaking operations.

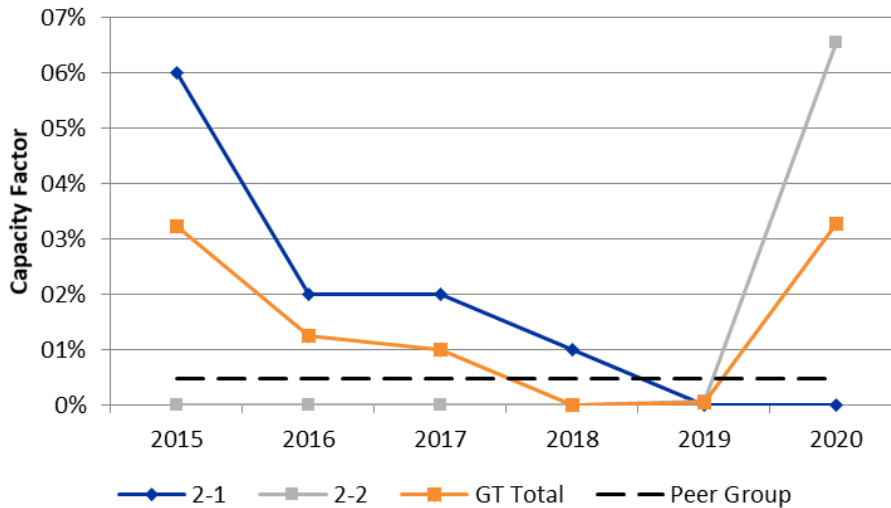
Figure 6-16 — Aguirre GT Units Capacity Factor

Figure 6-16 shows that the black-start GT net capacity factor over the last five years has generally been above that of its peer group. The peer group shows an NCF indicative of black-start units while the Aguirre units are used for peaking generation at times. As noted previously, GT 2-2 is used for emergency generation due to the high oil temperature; GT 2-1 has been out of service since January 2019.

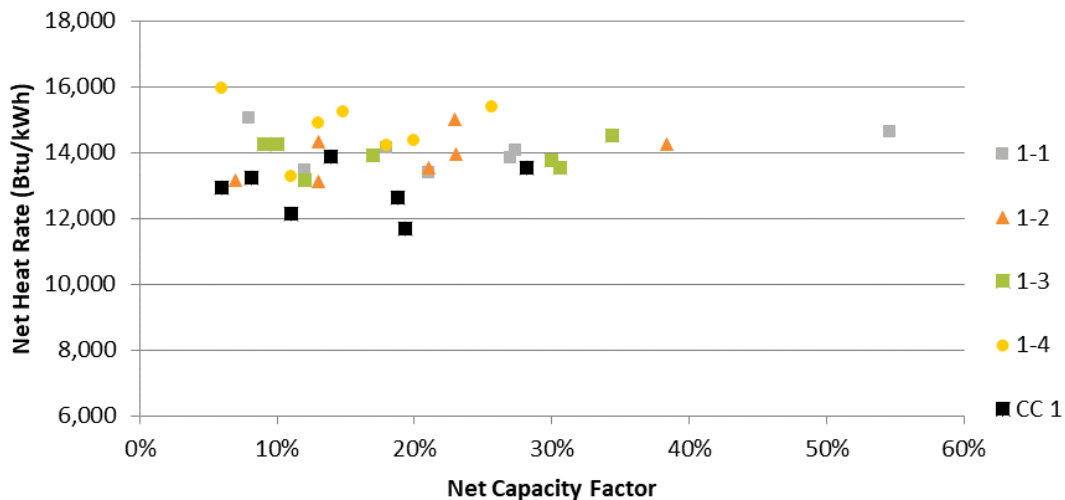
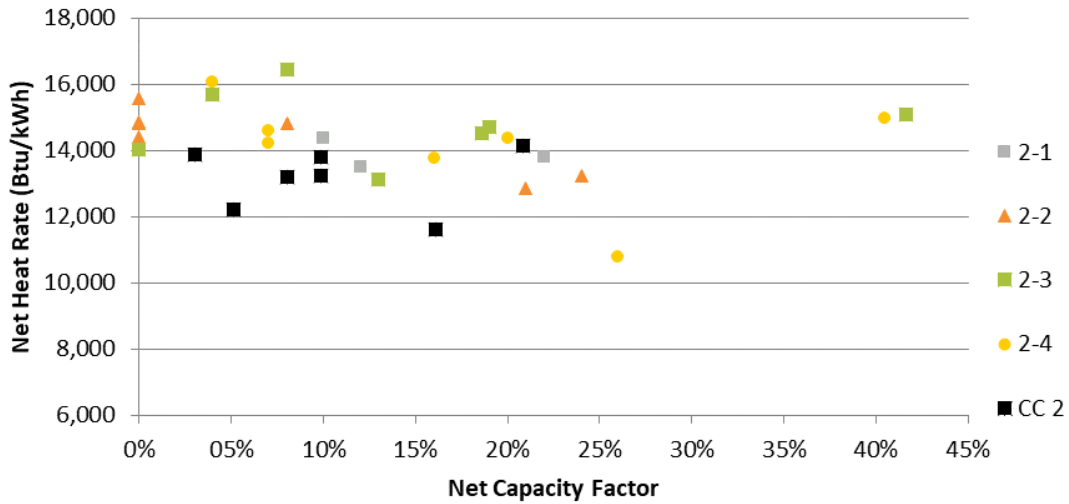
The net heat rates below for the CC units show the GTs separately, while the contribution from the STG is seen in the “Total” category. The total heat rate is the sum of the GT fuel input in Btu divided by the sum of the GT and ST net power output in kWh. The heat rates are high (unfavorable) for both STAG units, which is to be expected considering their high percentage of simple-cycle dispatch.

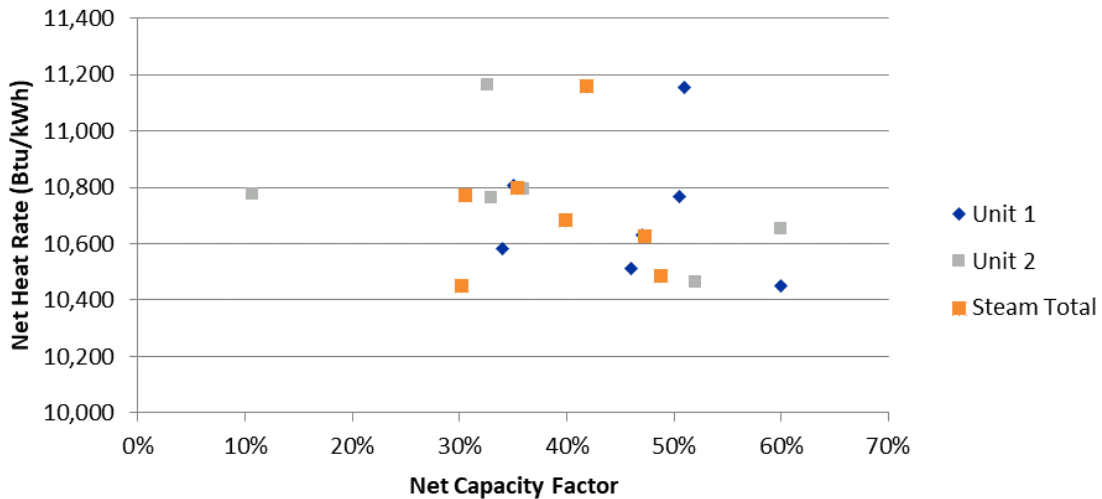
Figure 6-19 — Aguirre Thermal Plant Heat Rate v. Capacity Factor

The thermal units have similar heat rates to each other. An analysis of the data shows their heat rates are fairly steady as the unit’s capacity factor decreases. This may indicate a unit is operating at a similar load at all capacity factors but is operating there for shorter durations at the lower capacity factors. If it were operating at lower loads at lower capacity factors, a higher heat rate would be expected, as units typically lose efficiency at reduced loads. The Aguirre thermal plant heat rates are shown in Figure 6-19 (note the scale of the heat rate numbers on the left axis).

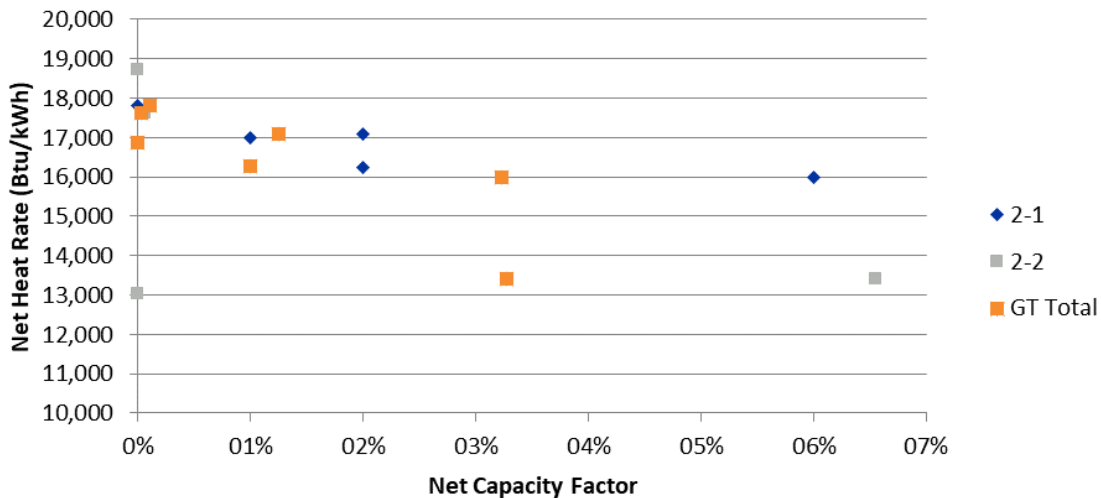
Figure 6-20 — Aguirre GT Units Heat Rate v. Capacity Factor

The heat rate of the black-start GTs is fairly high, which is expected due to their low operation; however, the heat rate declines consistently at higher capacity factors.
